# **INDOOR AIR QUALITY ASSESSMENT**

**Gardner Middle School  
297 Catherine Street  
Gardner, Massachusetts**

Prepared by:  
Massachusetts Department of Public Health  
Bureau of Environmental Health Assessment  
August, 2003

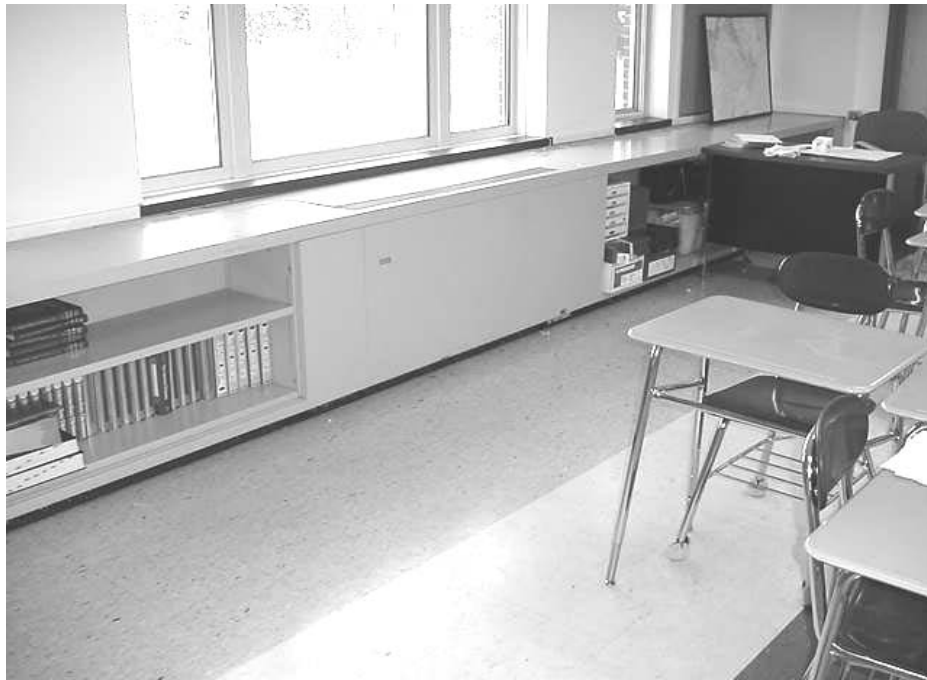
**Picture 1**

Fresh air in classrooms throughout the building is provided by unit ventilators (univents) ([Figure 1](#), Picture 1). Univents draw air from outdoors through a fresh air intake located on the exterior walls of the building and return air through an air intake located at the base of each unit. The mixture of fresh and return air is drawn through a filter and heating coil and is then provided to the classroom from the univent by motorized fans through a fresh air diffuser on the top of the unit. Univents were operating in all areas surveyed; however, a number of units were obstructed. One univent had its return vent blocked with wood planks (Picture 2). To function as designed, univent diffusers and returns must remain free of obstructions.

A number of other conditions that can potentially affect indoor air quality were also observed. In an effort to reduce noise from sliding chairs and tables, tennis balls were sliced open and placed on chair legs. Tennis balls are made of a number of materials that are a source of respiratory irritants. Constant wearing of tennis balls can produce fibers and off-gas VOCs. Tennis balls are made with a natural rubber latex bladder, which becomes abraded when used as a chair leg pad. Use of tennis balls in this manner may introduce latex dust into the school environment. Some individuals are

**Univent, Note Tennis Balls on Chair**

9. Consider discontinuing the use of tennis balls on chairs to prevent latex dust generation.
  10. Replace water damaged ceiling tiles.

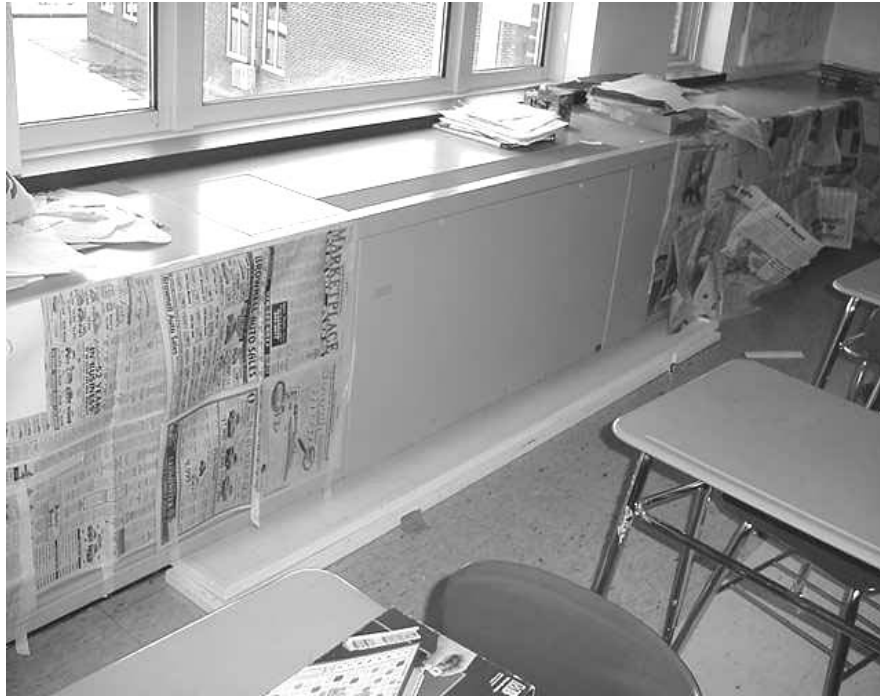
**Picture 2**

**Univent Return Vent Blocked with Plank**

1. Continue with plans to balance the ventilation system during the 2003 summer break.
2. Remove all obstructions from univent air diffusers and return vents to facilitate airflow.
3. Determine if weep holes exist in the south wall of GMS. Unearth all weep holes in exterior walls to maximize water drainage from exterior wall systems.
4. Encourage faculty and staff to report any complaints concerning temperature control/preventive maintenance issues to the facilities department in the form of a work order. These work orders are reportedly provided by the school maintenance staff and/or administration.
5. For buildings in New England, periods of low relative humidity during the winter are often unavoidable. Therefore, scrupulous cleaning practices should be adopted to minimize common indoor air contaminants whose irritant effects can

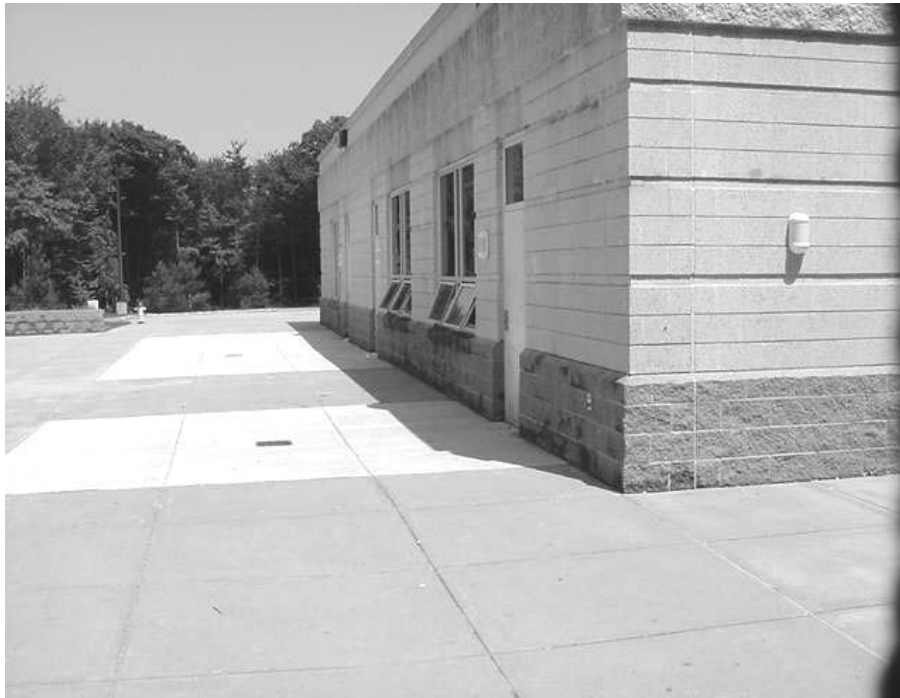
**Picture 3**

As indicated by school personnel, the teachers' room has been a source of concern due to the sloping of the sidewalk outside this area towards the building (Picture 3). An examination of the perimeter revealed large gaps in the sidewalk/exterior wall junction, which allows for accumulation of rainwater (Picture 4). Water penetration through an

**Sidewalk outside Teacher's Lunch Room**

11. Slope sidewalk away from teachers' lunchroom. Seal sidewalk/exterior wall junction with an appropriate sealing compound.
12. Continue with plans to remove carpet from teachers' lunchroom and replace with tile.
13. Consider adopting the US EPA document, "Tools for Schools" (US EPA, 1992) as recommended by the Athol Board of Health as a means to maintaining a good indoor air quality environment in the building. This document can be downloaded from the Internet at <http://www.epa.gov/iaq/schools/index.html>.
14. For further building-wide evaluations and advice on maintaining public buildings, refer to the resource manual and other related indoor air quality documents located on the MDPH's website at <http://www.state.ma.us/dph/beha/iaq/iaqhome.htm>.

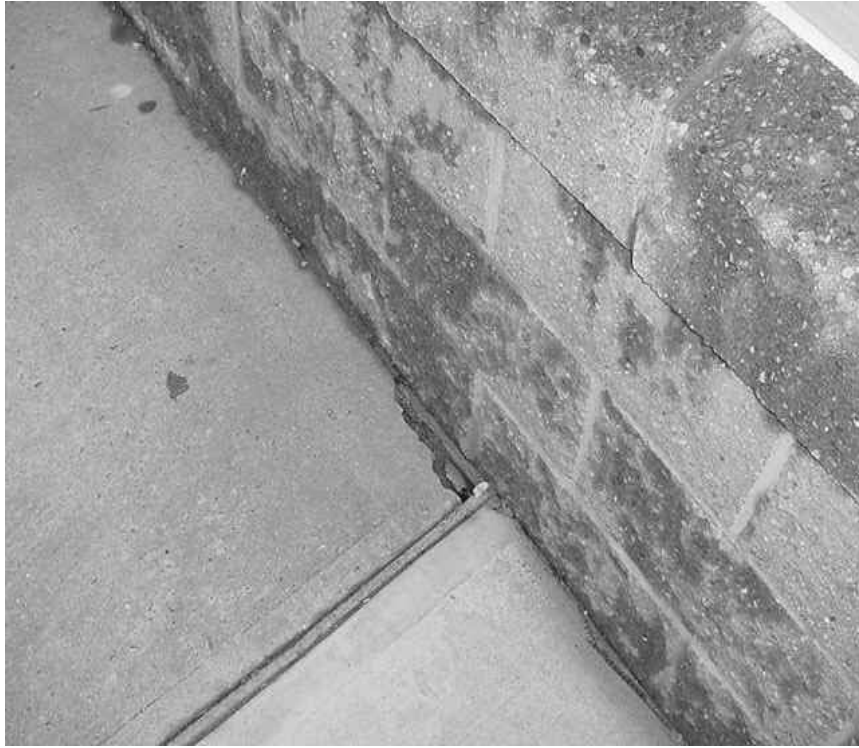
**Picture 4**

**Teacher's Lunch Room Exterior Wall/Sidewalk Junction**

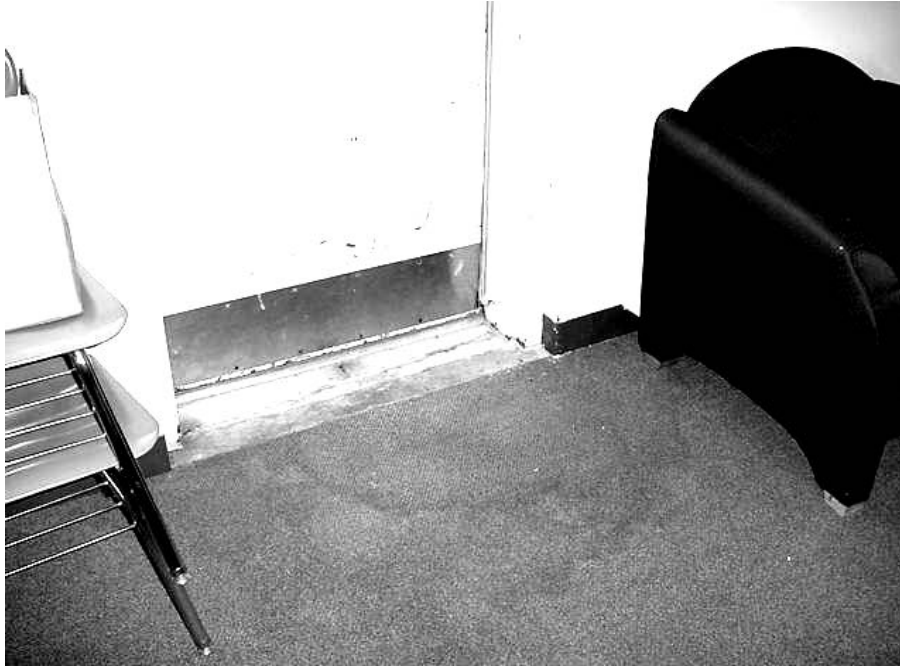
**Picture 5**

exterior door was noted in the doorframe (Picture 5). The teachers' lunchroom floor is covered with wall-to-wall carpeting. The carpeting installed to the door threshold and doorframe showed signs of water damage (Picture 5). Moisture samples were taken from the carpeting. Most areas of carpeting had detectable levels of moisture, indicated that the carpet near the exterior wall was saturated. GPS staff planned to remove the carpet and install tile after moistened carpeting was found in the teachers' lunchroom. According to Paul Schaeffer, GPS, no accumulated water was found underneath the carpet along exterior walls (personal communication, Schaeffer, 2003).

**Teacher's Lunch Room Exterior Wall Doorframe, Note Water Stain in Carpet**

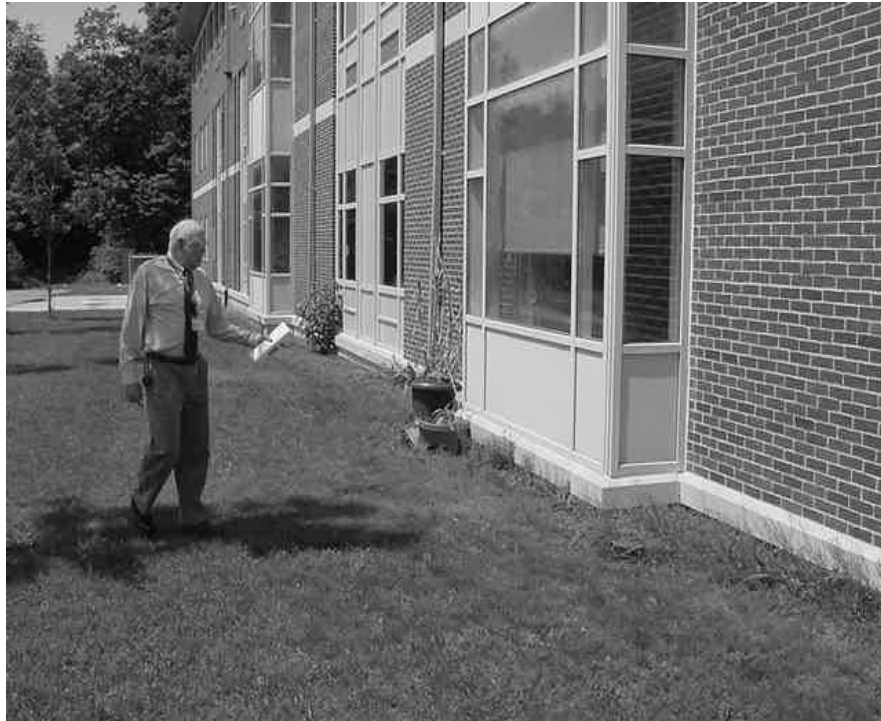
**Picture 6**

The exterior of the GMS consists of a traditional red brick exterior wall (Picture 6). An examination of the exterior brick walls of GMS was conducted to identify the location and condition of weep holes. Weep holes were found above grade on the west, north and east facing exterior walls (Picture 7). Weep holes in these walls were open. In contrast, the south exterior wall of GMS did not have identifiable weep holes. Since the south wall is of similar design to the rest of the building, weep holes in this section may be buried by accumulated loam, dirt or cedar flakes along the edge of these walls. It is advised that “[i]n no case should the holes be located below grade”, since dirt can fill weep holes to prevent drainage (Dalzell, 1955).

**GMS Consists of A Traditional Red Brick Exterior Wall**

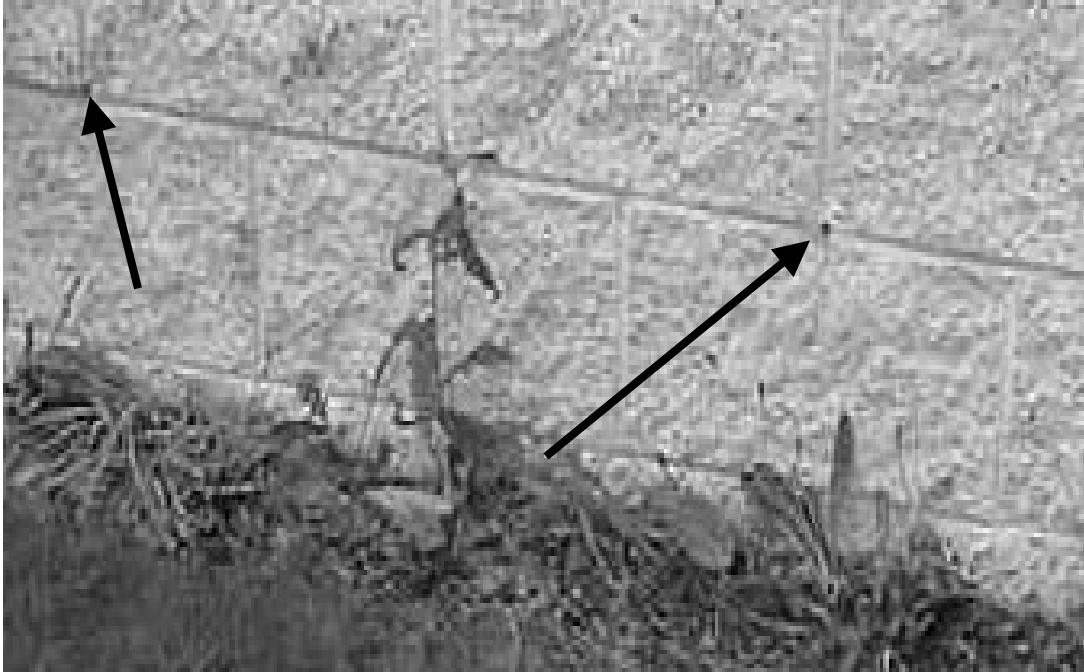
**Picture 7**

**Weep Holes Were Found Above Grade on the North Facing Exterior Wall of GMS**
